NASA Technical Paper 1193

Influence of Fretting on Flexural Fatigue of 304 Stainless Steel and Mild Steel

Robert C. Bill and Douglas A. Rohn

APRIL 1978

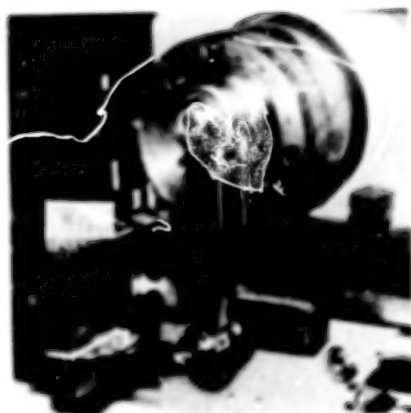
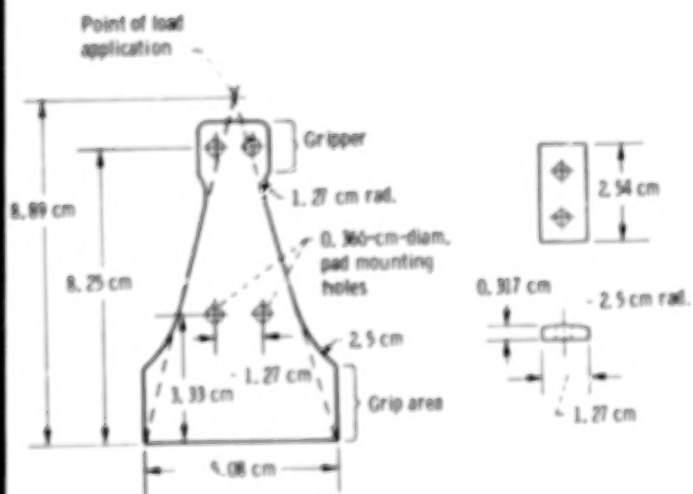
Figure 1. - Test apparatus and specimen.

The fretting-fatigue apparatus used in this investigation is shown in figure 1(a). The standard flexural-fatigue machine consists of a variable-speed motor, eccentric head, connecting rod, specimen grip, and vise clamp. Rotation of the head causes the connecting rod to flex the end of the specimen. The eccentric head can be set to provide zero- to 5.08-centimeter (2-in.), peak-to-peak deflection at the end of the connecting rod. Flexural stresses can be calculated from this deflection considering specimen geometry and material constants. A counter records head revolutions, and after specimen failure a shutdown switch is tripped by the connecting rod.

The fatigue specimen is in the form of a constant-stress-cross-section, flexural sheet, 0.75-millimeter (0.030-in.) thick. As indicated in figure 1(b) the specimen geometry is basically triangular. The relation between width and height of this triangle is determined so that, when end loaded as a cantilever beam, the ratio of bending moment to cross-sectional moment of inertia is the same at all points along the specimen. Thus the bending stresses are equal over the beam's length. Outside the constant-stress area are the vise mounting and connecting rod clamping areas, with fillets to reduce stress concentrations.

As indicated in figure 1(b), two holes are provided in the constant-stress portion of all specimens to permit mounting of the fretting pads. The stress concentration factor associated with the mounting holes is calculated to be 1.59 (ref. 13). All fatigue-stress levels discussed reflect nominal flexural stresses in the fatigue specimen, and do not consider stress-concentration effects due to the presence of the holes.

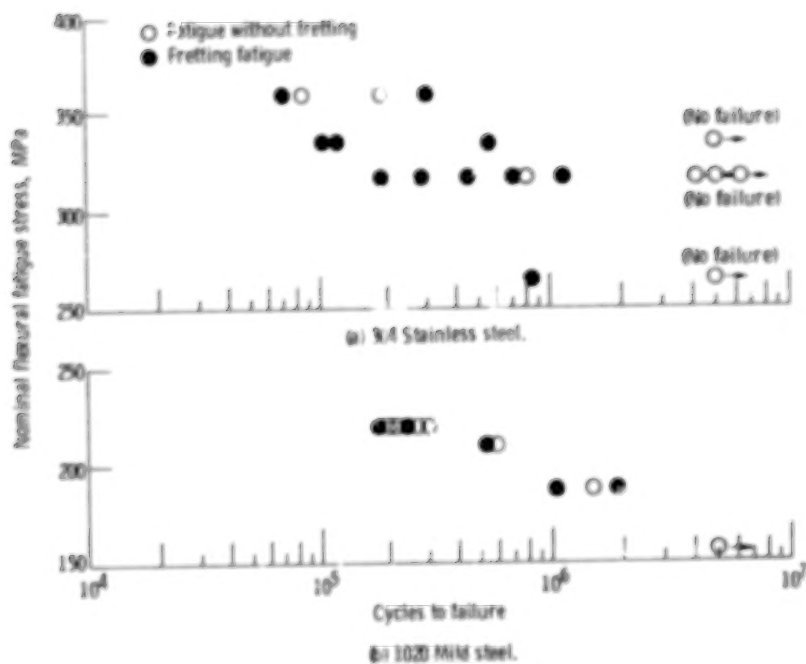
The fretted and unfretted fatigue lives of 304 stainless steel and 1020 steel at various flexural-stress levels are shown in figure 2. It is apparent that fretting effects the fatigue life of 304 stainless steel much more than 1020 steel. The greater resistance of 1020 steel to this type of fatigue may be a consequence of plastic flow in 1020 steel under the combined contact and flexural stresses. When plane-strain conditions prevail, the combined-stress condition may be expressed as

Fretting has a much more significant effect on the fatigue life of 304 stainless steel at the lower flexural-stress levels shown in figure 2. Fatigue-life reductions of as much as a factor of 10 are indicated at 265, 317, and 334 megapascals (38 500, 46 000, and 48 500 psi). No effect due to fretting is observed at 359 megapascals (52 000 psi). This might be expected because at the higher stress level, the unfretted fatigue life is so short that it is nearly the same as the number of cycles required to accumulate fretting damage.

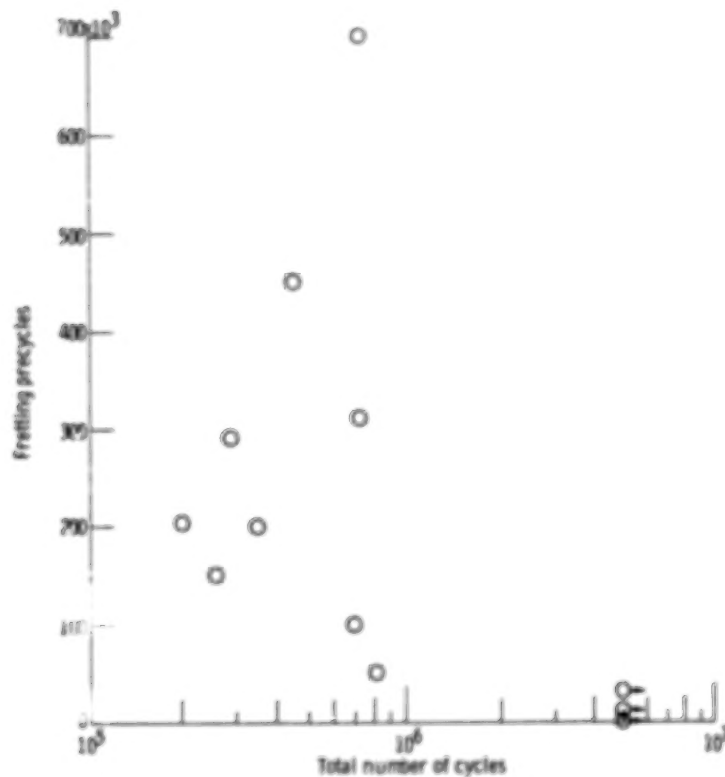
Figure 3 - Two part fretting fatigue of 304 stainless steel. Fatigue stress, 337 megapascals.

The results of the two-part fretting fatigue experiments on 304 stainless steel are summarized in figure 3. The salient point is the presence of a fretting-fatigue threshold as was reported by Hoepfner and Goss for Ti-6Al-4V in reference 10. It appears that fewer than 30 000 fretting cycles are insufficient to initiate the surface damage necessary to start a crack. After about fretting 50 000 cycles, the damage is done, so to

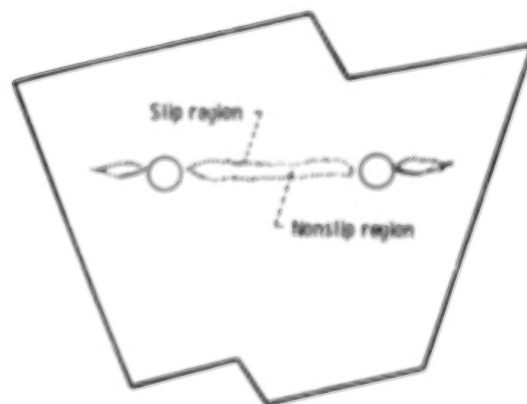
Figure 4 - Distribution of slip and nonslip regions in fretting fatigue flexural specimen.

The fretting-pad contact pattern seen on the fatigue specimen surface after failure is shown schematically in figure 4. There are two distinct regions associated with the contact area, namely, regions of slip and regions of nonslip. Slip regions completely enclose the nonslip central regions, and are characterized by very fine fretting surface damage, as may be seen in figure 5. The nonslip central regions show virtually no evidence of surface distress.

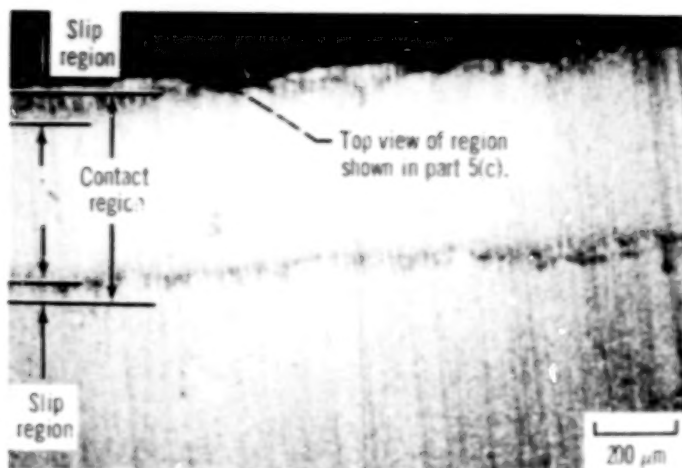
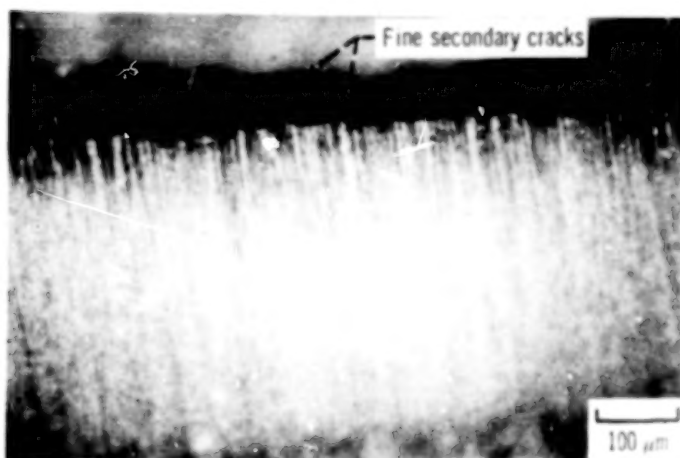
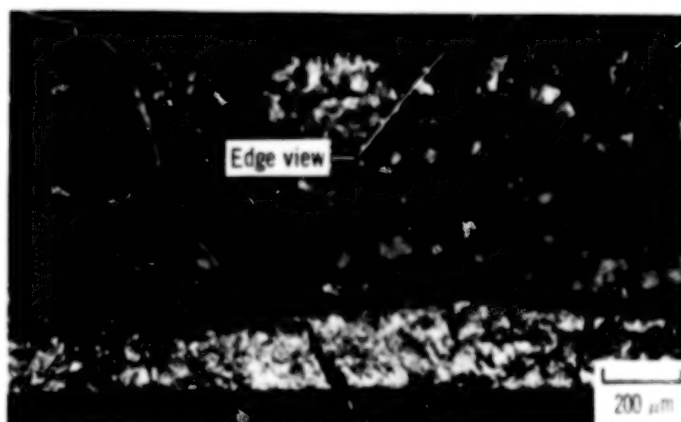
(a) Overview of contact region on fractured fretting fatigue specimen.

(b) Close-up of edge of fracture surface.

(c) Edge view showing fracture surface.

Figure 5. - Photomicrographs of fretted surface and fracture surface of 304 stainless-steel specimen after fretting fatigue failure under ± 317 -megapascal flexural-fatigue-stress experiment.

Examination of fretting-fatigue specimens indicates that both the primary fatigue crack (the one that led to final failure) and secondary cracks that did not propagate to failure began in the slip regions of the contact area. Figure 5 clearly shows the interaction of the fretting region with the final fatigue failure, as well as numerous fine cracks near the fracture edge that did not propagate to failure. The fracture surface (fig. 5(b)) correlates with the plan view (fig. 5(a)) and shows numerous crack-initiation sites.

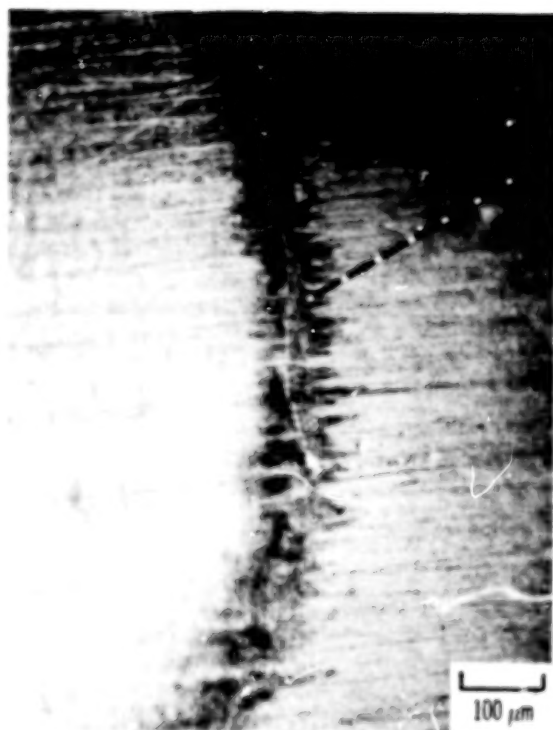
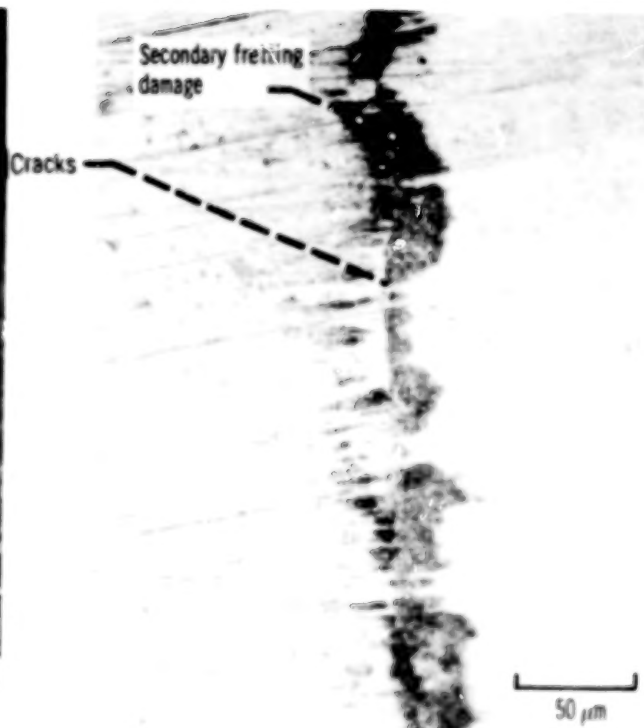
(a) Region near one of bolt holes.

(b) Region showing secondary surface fretting damage

Figure 6. - Fretting fatigue cracks initiated in fretting region not adjacent to fracture surface. Flexural stress, ± 317 megapascals; 304 stainless steel.

Cracks were also observed in the fretted, slip region, not adjacent to the final fracture surface, as may be seen in figure 6. The especially heavy fretting surface damage in figure 6(b) on the side of the crack toward the vise grip is due to a "secondary" fretting effect. After the crack was able to propagate a considerable distance along the fatigue specimen, slip motion no longer varied smoothly over the original slip region. Rather, the crack acted as sort of a hinge forcing increased relative motion between the fretting pad and that part of the fatigue specimen toward the vise grip.

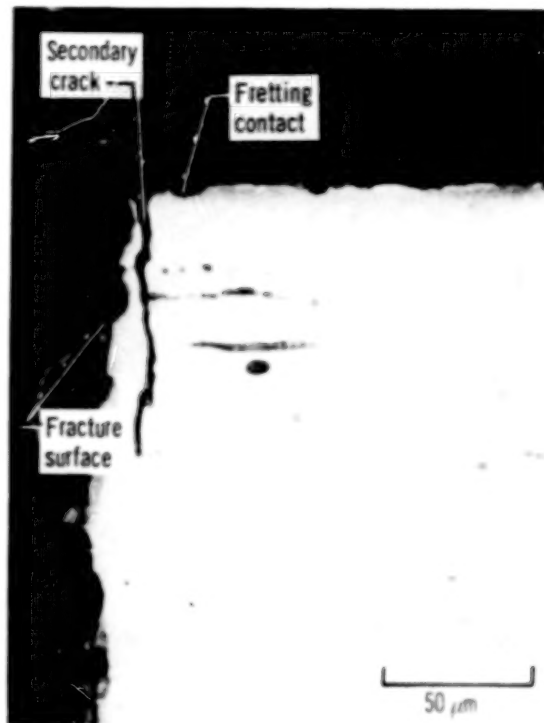
Figure 7. - Section through fracture surface. 304 stainless steel after fretting fatigue failure under ± 317 -megapascal flexural fatigue stress.

A section view of a fretting fatigue fracture surface is shown in figure 7. Evidence of surface pitting due to the fretting action may be seen. Of particular interest is the crack that was initiated in the fretting area but did not link up with the primary crack.

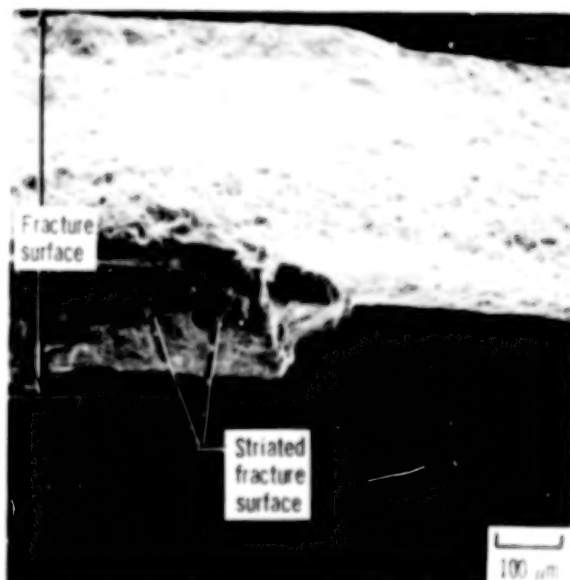
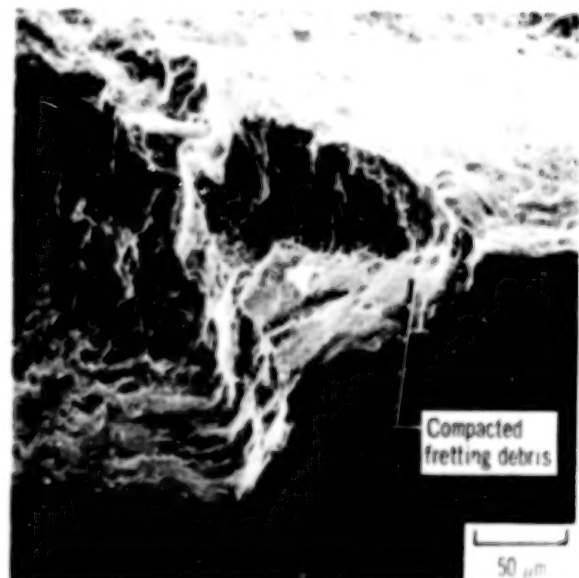
(a) Overview showing area of rapid crack propagation.

(b) Close-up showing adherent compacted fretting debris.

Figure 8. - Scanning electron micrographs of fretting fatigue fracture surface on 304 stainless steel. Flexural fatigue stress, ± 317 megapascals.

Fracture-surface features on the flexural-fatigue specimens are shown in figure 8. Two distinct regions are seen on the fracture surface. Near the contact surface where fretting takes place, there is evidence of rapid crack growth into the fatigue specimen, as indicated by the distinctly striated areas. With increasing depth into the fatigue specimen, a region is encountered in which cracks propagate parallel to the bending

axis as well as into the specimen. The "smeared" appearing areas on the fracture surface of figure 8(b) are caused by adherent, compacted fretting debris.

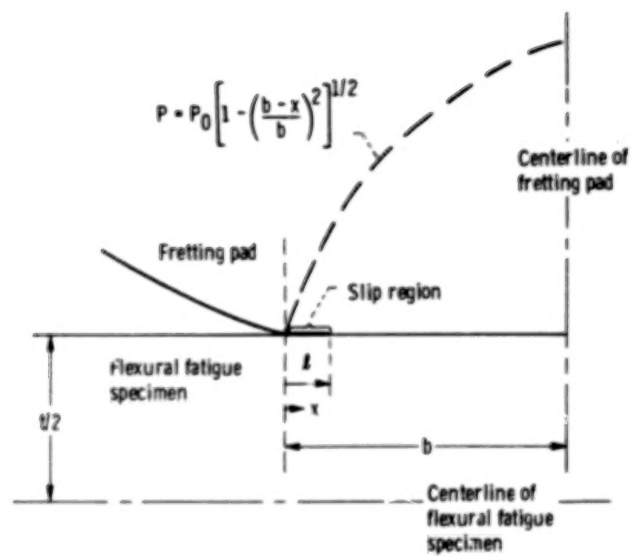
Figure 9. - Features of contact geometry of fretting pad and flexural fatigue specimen.

The portion of the contact region between the fretting pad and the flexural fatigue specimen actually undergoing slip, as shown in figure 9, is predicted based on analogy with some results developed for cracks (ref. 14). Shear displacement between the surfaces in the slip region follows from surface displacement distribution for an elliptical crack, according to the equation
